Nondestructive Inspection for Structural Safety of Historical Buddhist Temple "Zenkoh-ji" San-mon

Y. SASAKI¹, M. YAMASAKI², A. INABA³, Y. TSUJITA³, K. TAKAHASHI⁴, and M. SUMIOKA⁴

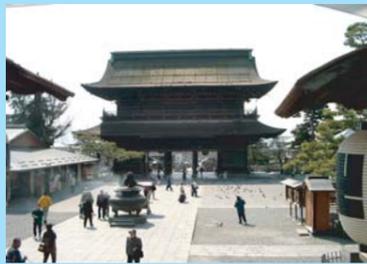
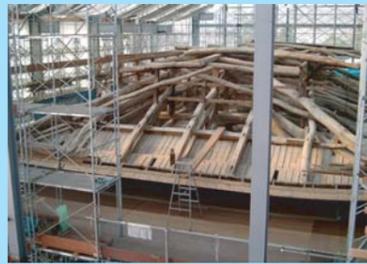
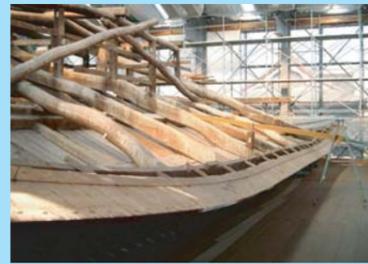
San-mon of Zenkoh-ji, before and under repairing.

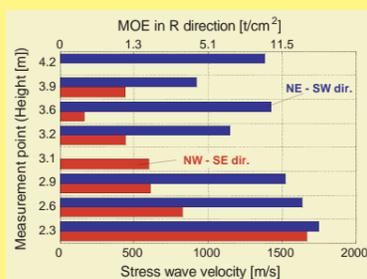
Fig. 1. Stress wave velocity.

As an example of the measurement results, the stress wave velocity in the radial direction of the column of the first floor is shown in Fig. 1. About the column of the first floor "Marubashira" (Keyaki) shown in Fig. 2, the velocity was measured in two radial directions (NE-SW and NW-SE directions) perpendicular to each other, at the height for every 0.3 m. The velocities in NE-SW direction showed 1500 m/s order, and were judged to be in general appropriate. As an index of the measurement result, the equivalent elastic modulus in radial direction (ER) by setting the density to 500 kg/m³ was attached to the horizontal axis in Fig. 4. From this, when the stress wave velocity is about 1500 m/s, the general value on ER of Keyaki is acquired. It seemed that NE-SW direction showed the appropriate results according to Fig. 4. On the other hand, the stress wave velocities in NW-SE direction showed notably small values above 2.6 m height.

When the wave velocity is small, the existence of an internal defect other than a fall of elastic modulus can be considered. From this examination, the existence of the internal defect (for example, big crack) was guessed in the direction orthogonal oriented to the NW-SE direction, in the case of this column.

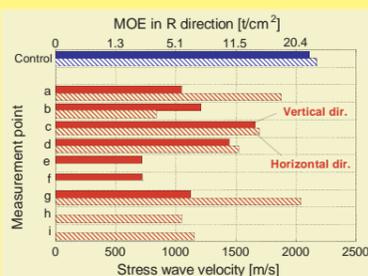
Fig. 3. Stress wave velocity.

The stress wave velocity in the longitudinal direction of an ascent beam "Noboribari" (Japanese red pine) was 4625 ± 343 m/s (equivalent elastic modulus 110 ± 17 t/cm²), and was judged to be appropriate value. The stress wave velocity in the radial direction of the material is shown in Fig. 6. The wave velocity shows small value in some measurement points. Velocity of the vertical direction shows small value especially near the front (measurement points "e", "f", and "g"). That is, in this measurement area, existence of internal defects, such as a crack, was able to be considered horizontally. This has supported judgment by viewing as shown in Fig. 5. On the other hand, the control material (neighbouring ascent beam) which is completely satisfactory according to viewing showed about 2000 m/s in wave velocity, and was judged to be normal.
